FEB2 “Slice” Testboard Update

Elena Busch
on behalf of Columbia (Nevis Laboratories)

10 March 2021

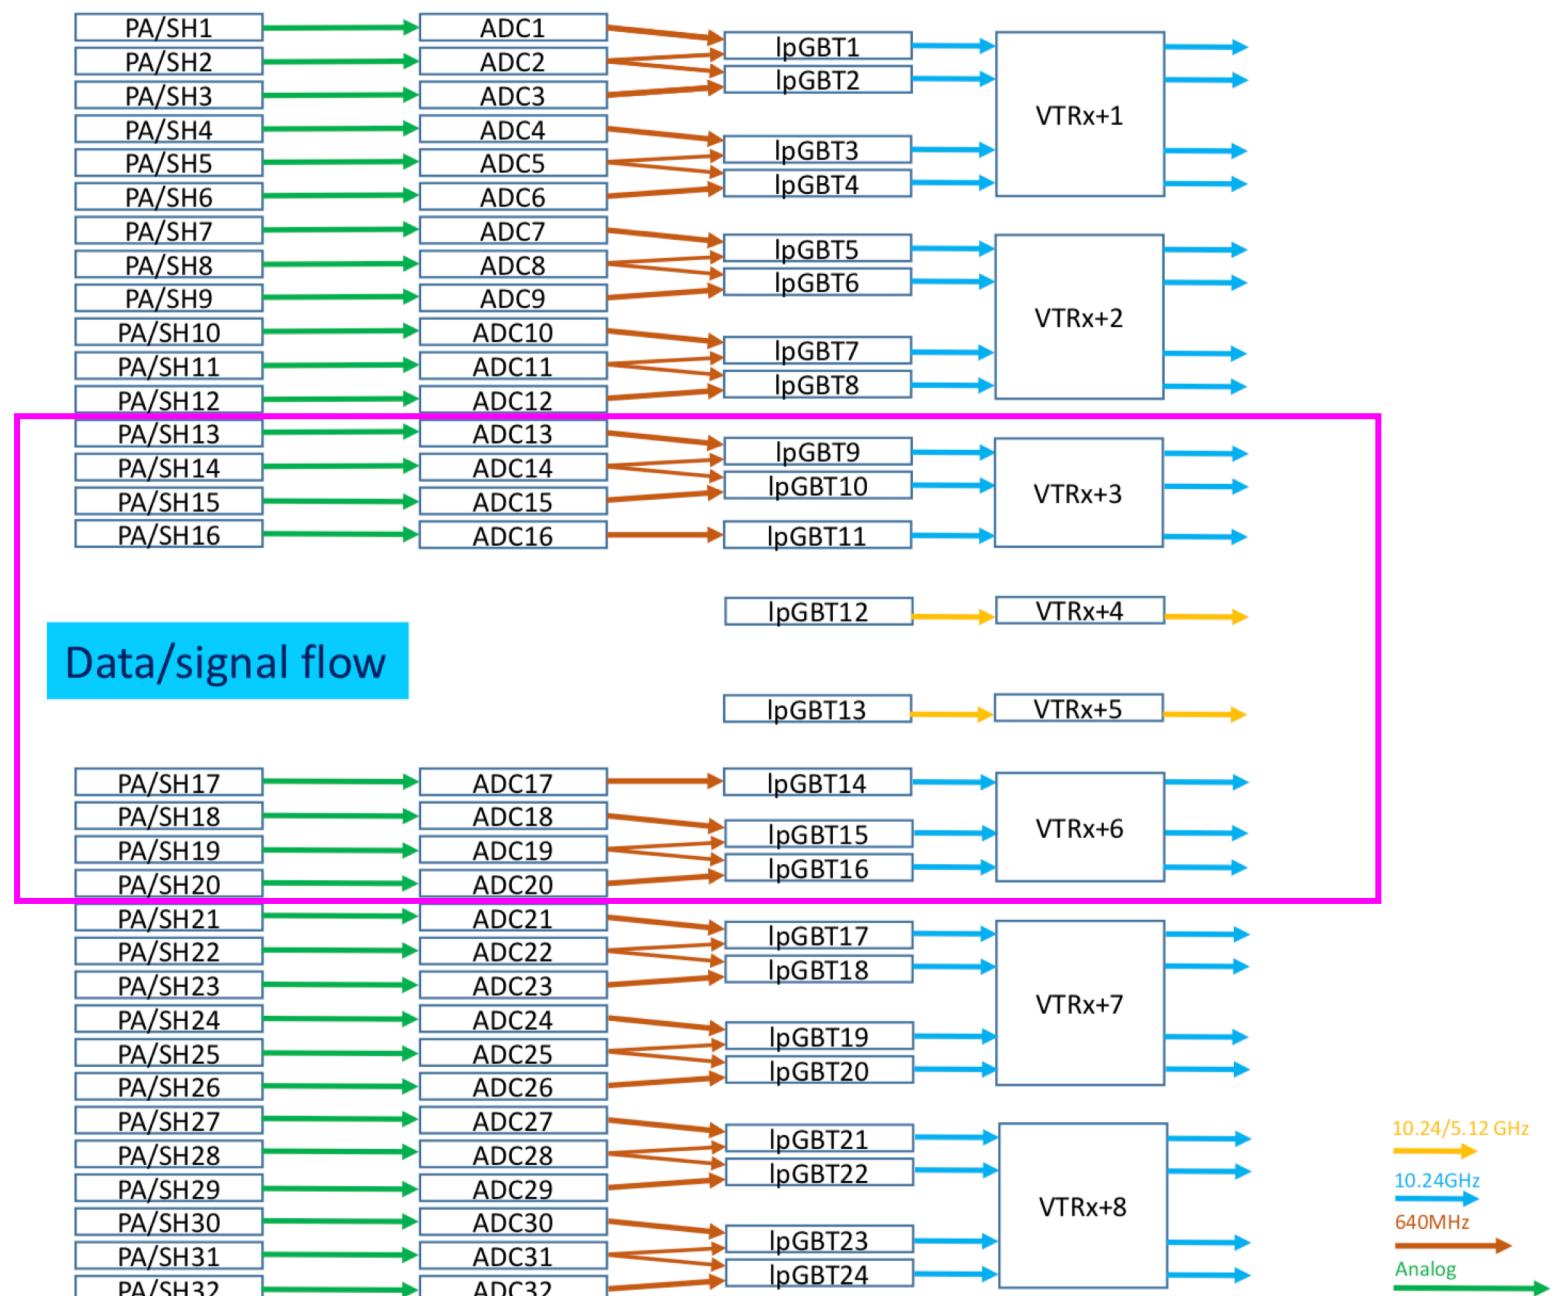
Review: FEB2 Data/Signal Flow

- V1.1 board assembled with full set of 8 PA/S, 8 ADCs, 8 IpGBTs
 - up from only 2 PA/S & 3 ADC on v1.0
- 32 channels of readout
 - Each channel represents a HI/LO gain pair
- Results will be shown only for the 16 MDAC channels

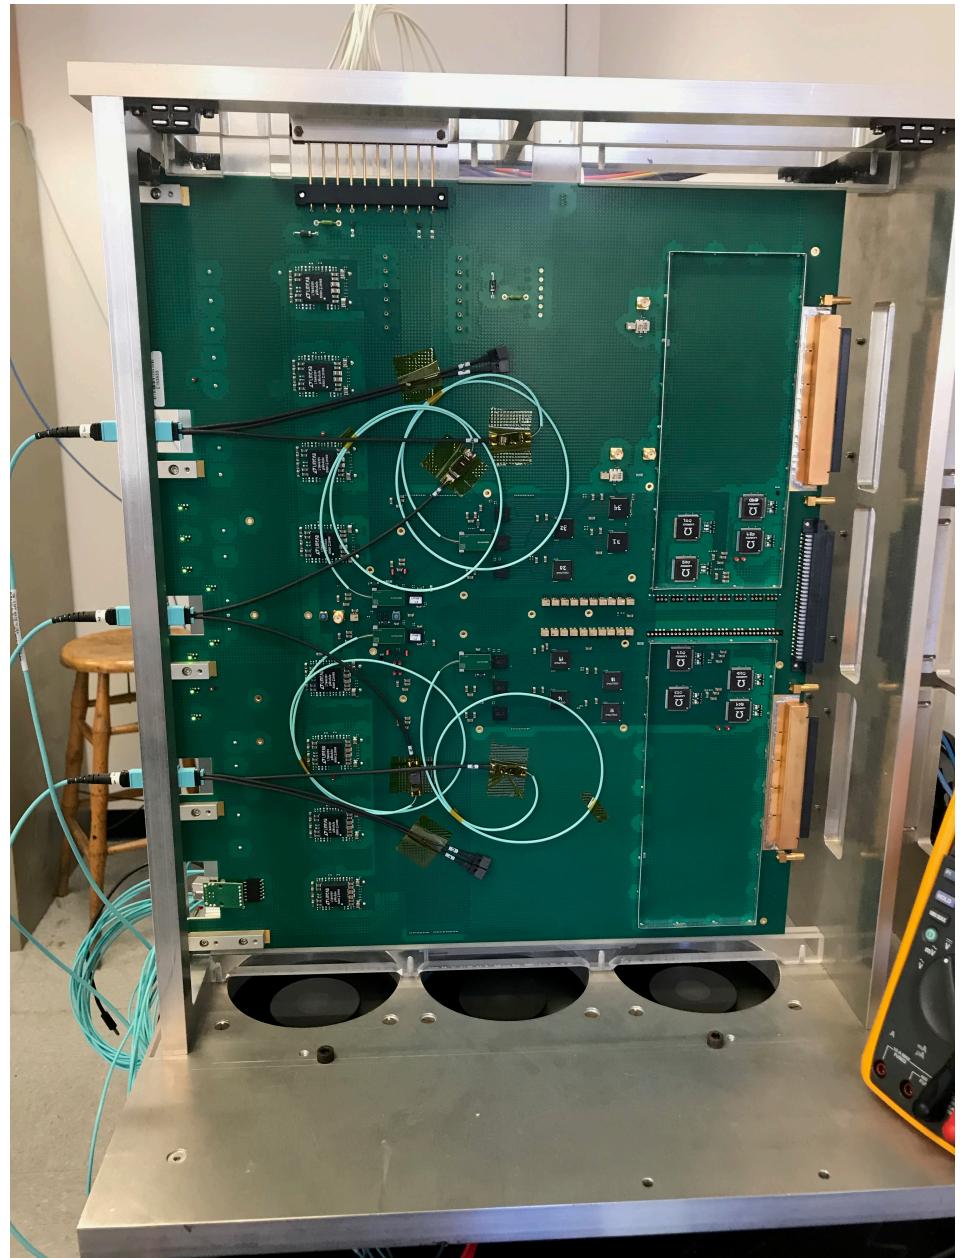
Features of v1.1

- New optical connections, designed by SMU
 - Front panel mounted connectors
- Fix for the IpGBT 12 & IpGBT13 master problem
 - The first time the board is brought up, we need to communicate with IpGBT12&13 to burn e-fuses
 - On v1.0, we had to cut the M2 lines to allow this communication
 - On v1.1, we can now isolate undefined IpGBT12&13 masters by changing the headers on the board
 - As soon as I2C buses are free we burn e-fuses on IpGBT12&13, and IpGBT11&14
 - This is a one time operation – once done the board can be fully operated via FELIX

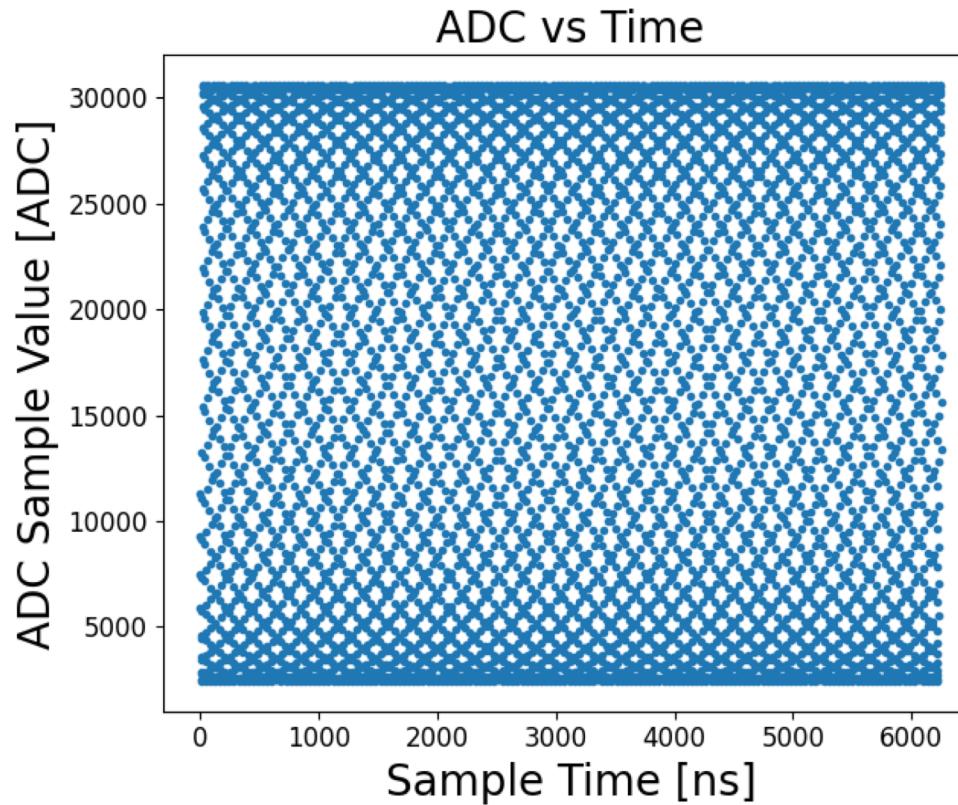
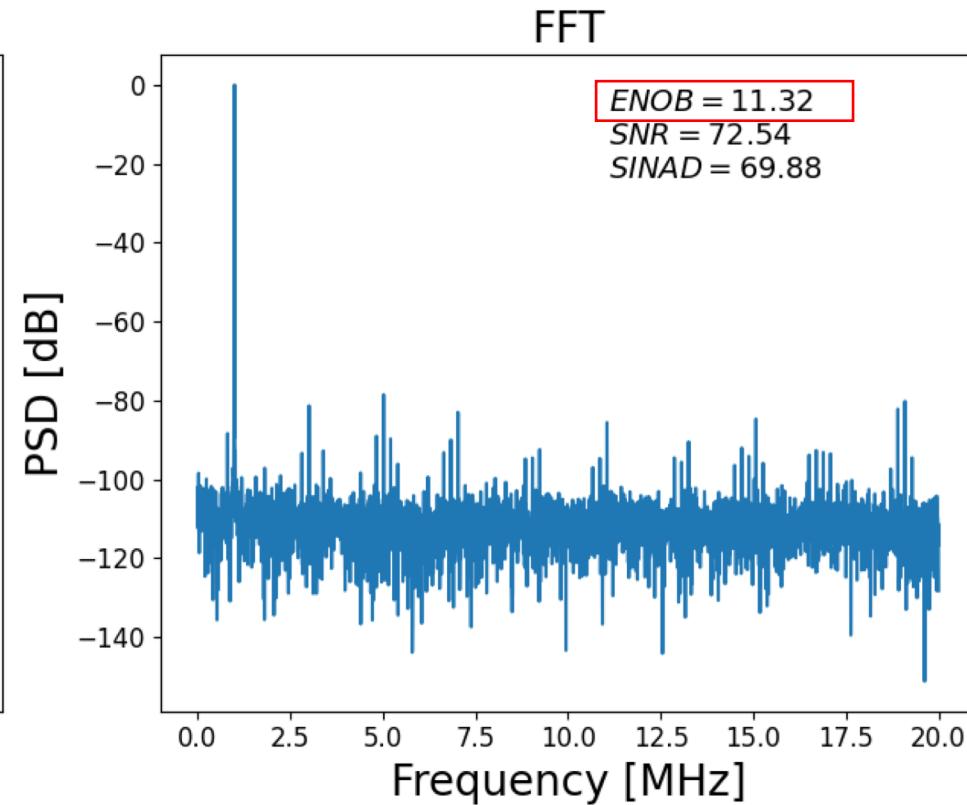
Sine Wave Results

* Spikes in the FFT are most likely due to the MDAC transition sample offset which is an understood problem – there is a solution planned for CV4

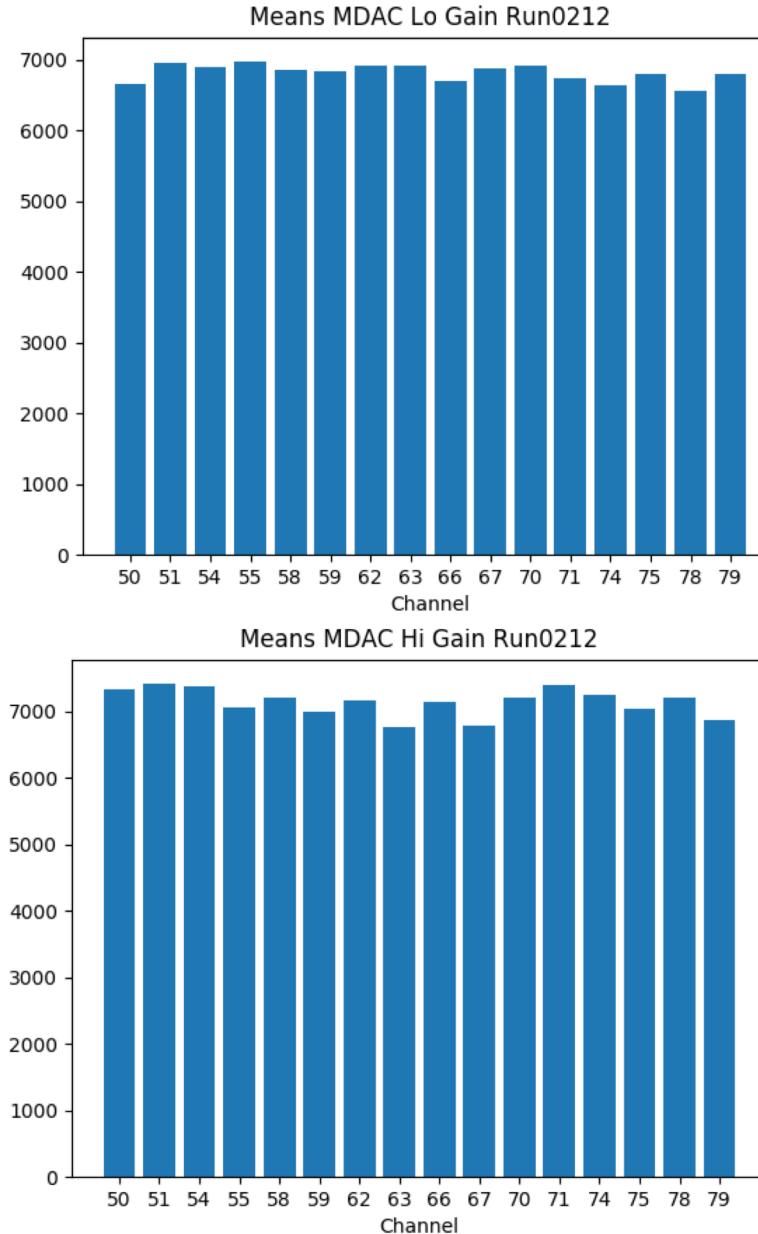
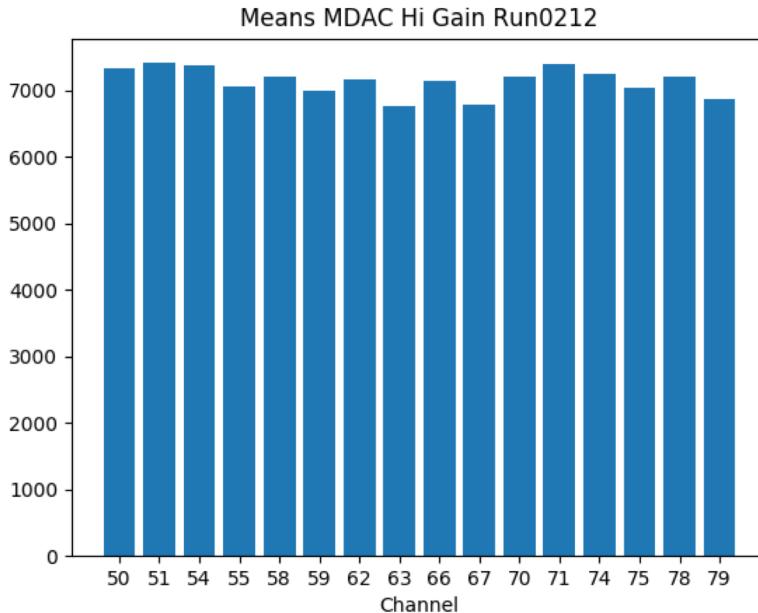
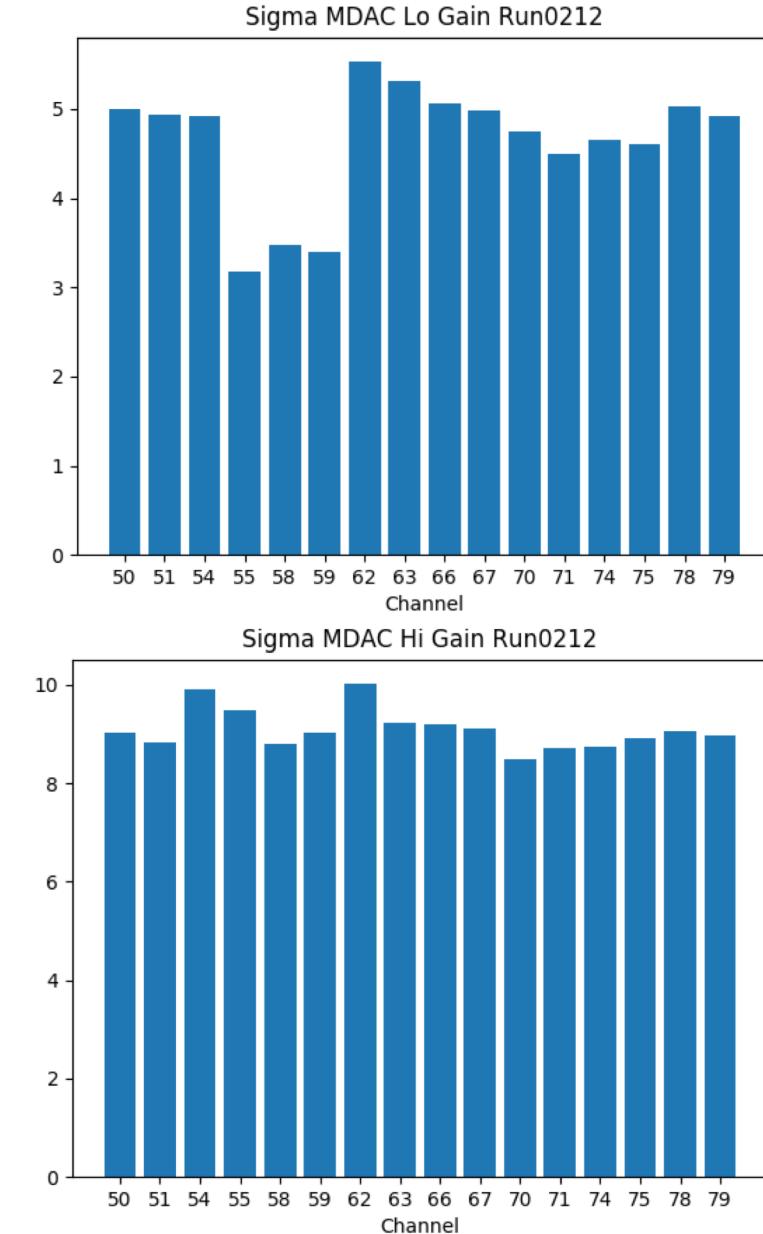
Noise Results

- Summary of noise results with the default PA/S parameters
 - The baselines have been adjusted so that all channels have a baseline close to 7000 counts
- On average we see ~ 9 counts of noise in the HG, and ~ 5 counts of noise in the LG
- These noise levels are higher than expected

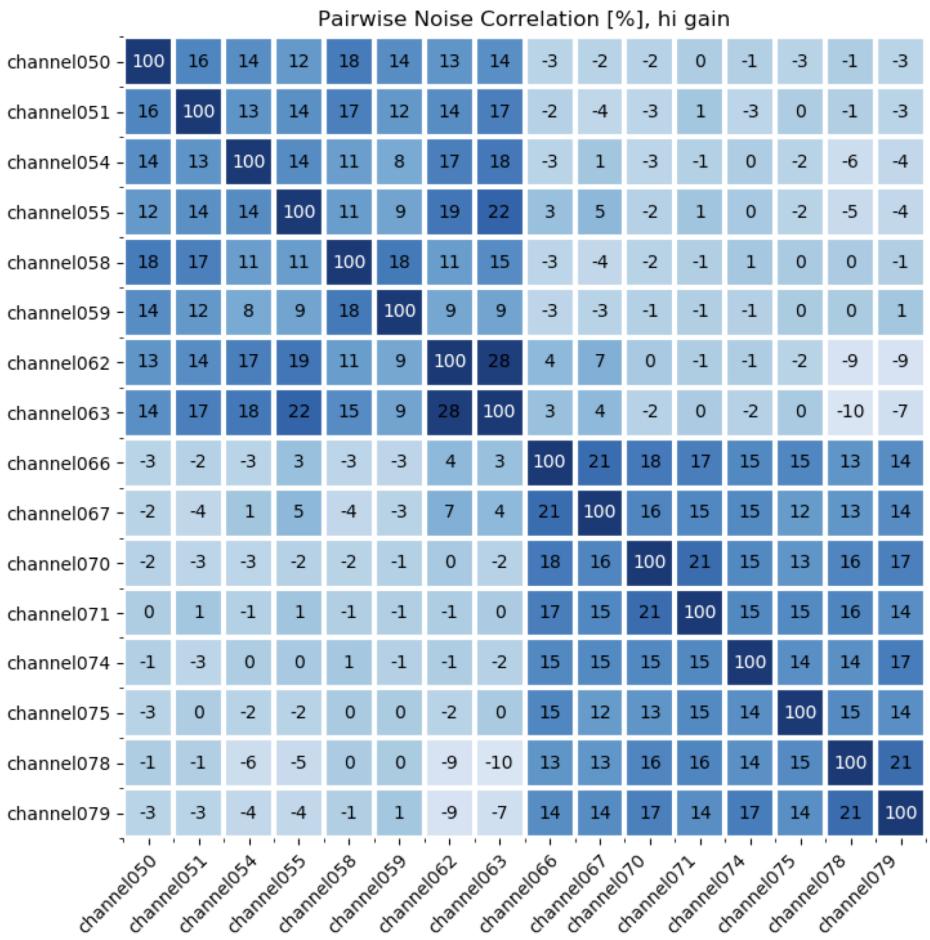
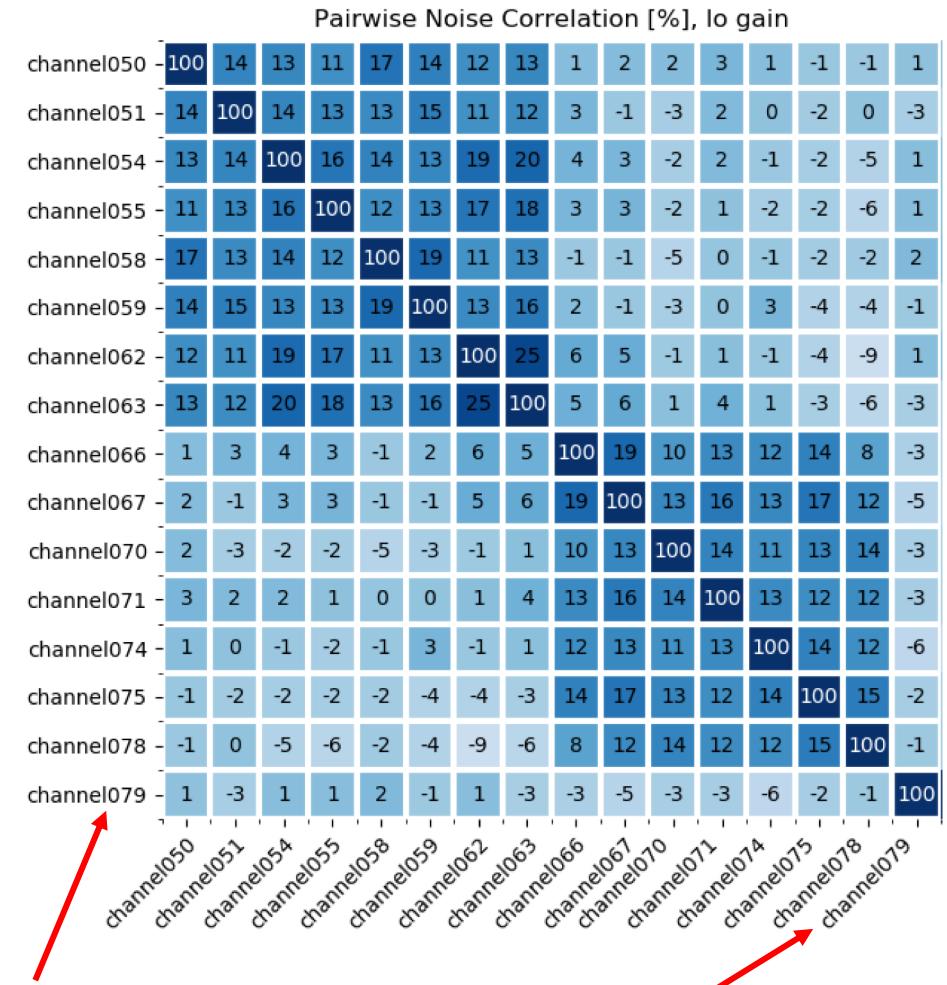
Noise Correlation

- Noise is correlated within each half of the board
- Within a half of the board, the noise correlation is mostly flat, and large (~10-20%)
- Opposite sides of the board are slightly negatively correlated

* Ch79 LG is disconnected from the PA/S

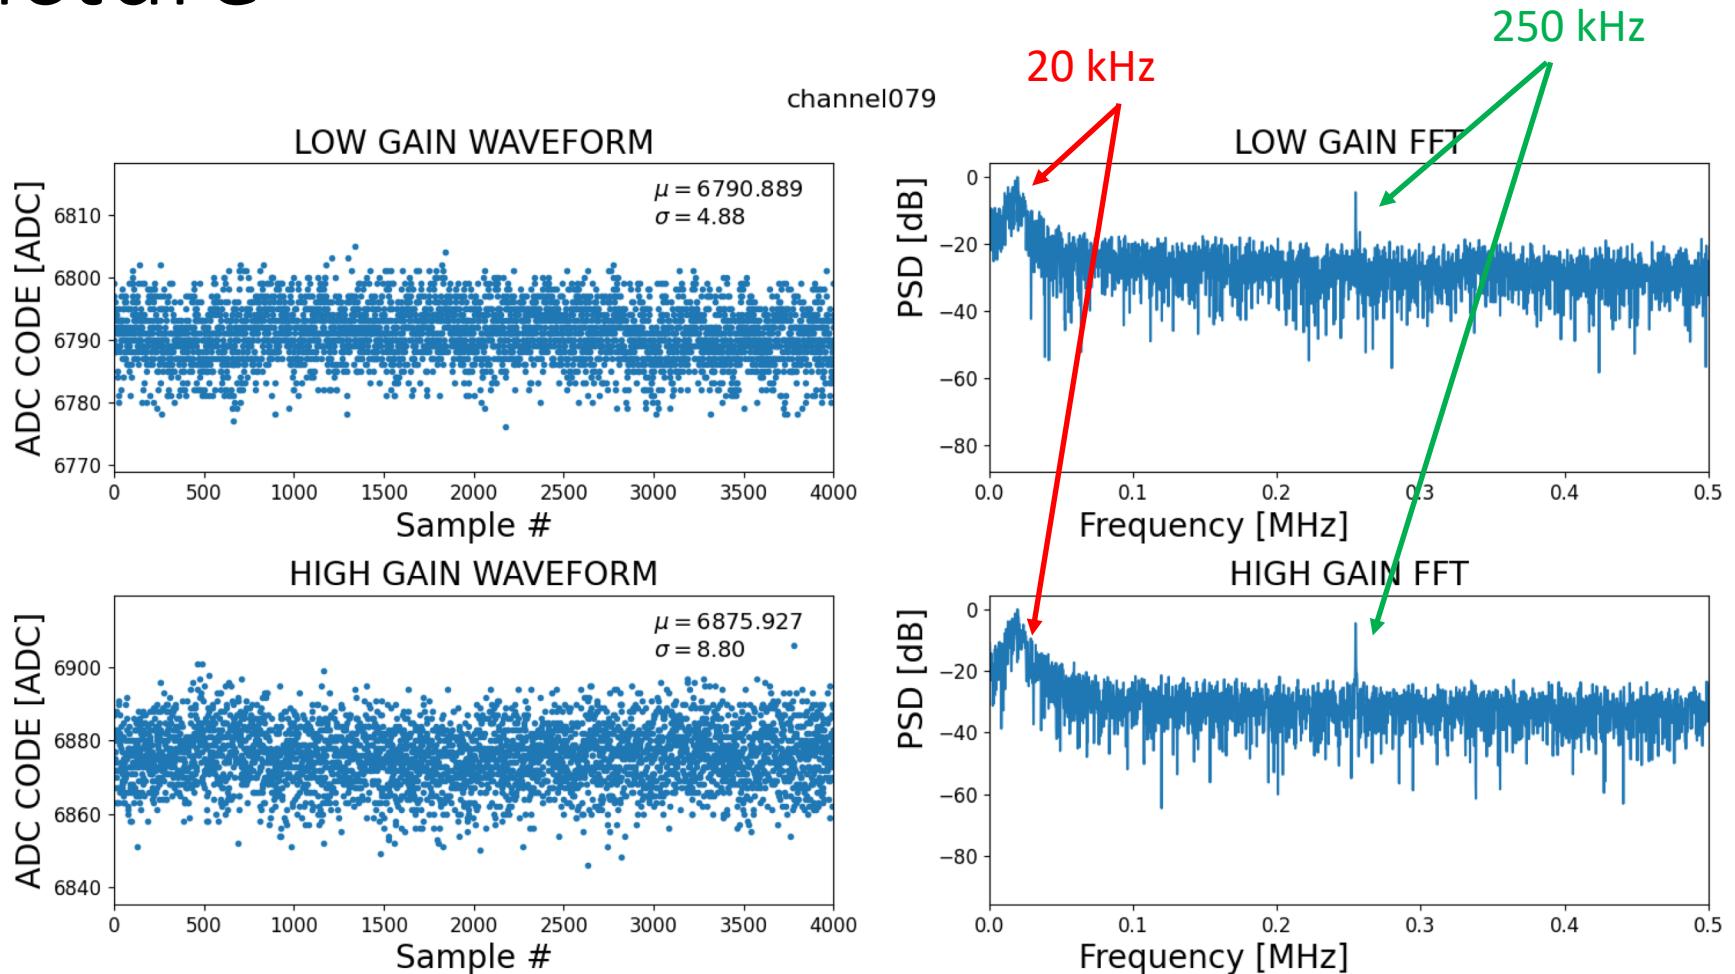
Noise Structure

- There is a prominent 250 kHz spike in the FFT of the pedestal data
- We also observe a broad peak around 20 kHz
- The DCDC converters operate at 250 kHz – we wanted to isolate them as the source of the 250 kHz spike

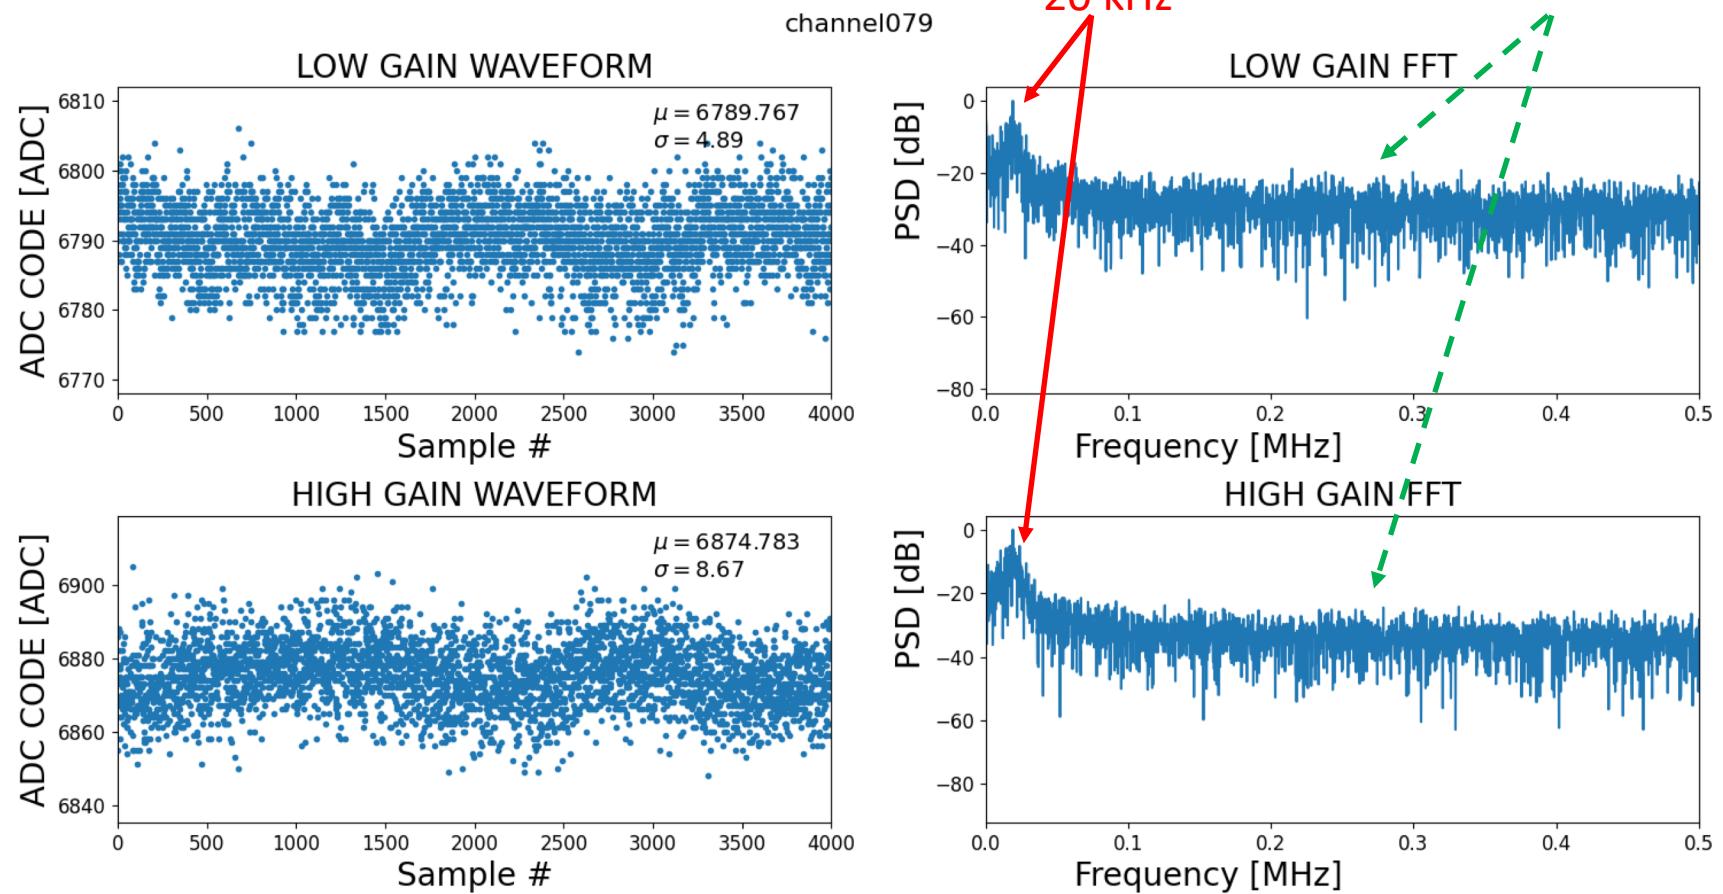
Noise with External Linear Power Supply

- For this measurement we bypass the DCDC converters with linear external power supplies
- We see the 250 kHz spike disappears, but the large peak around 20 kHz remains

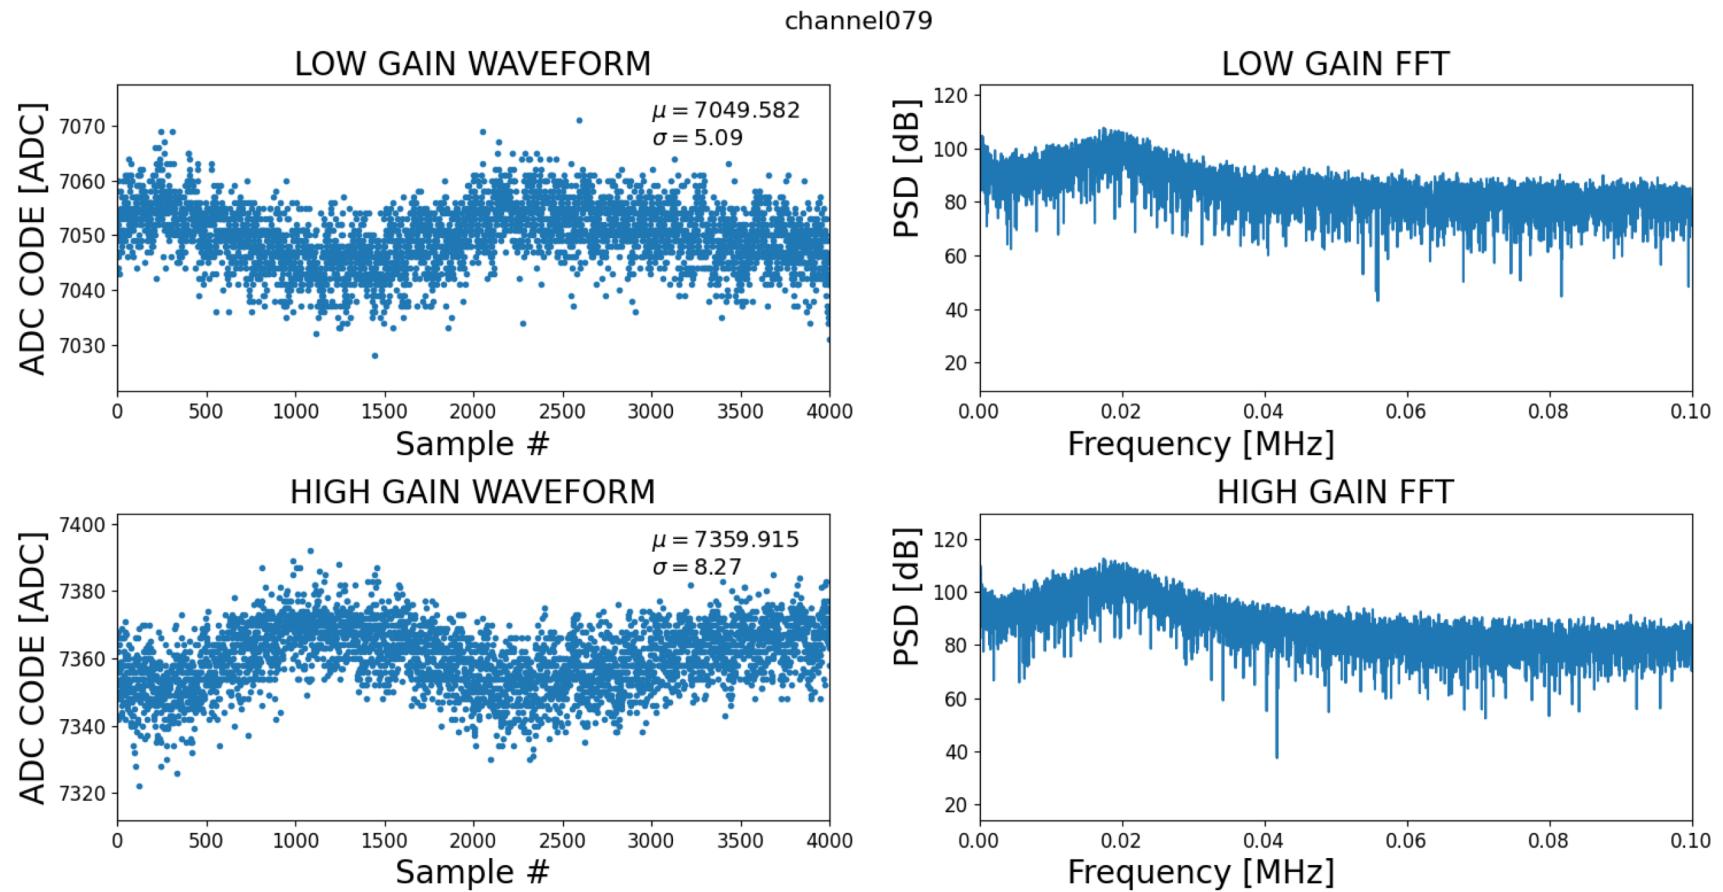
20 kHz Noise

- We see the 20kHz noise is very dominant in the noise distribution
- We would like to understand where the noise comes from, and how it couples to our measurements

We have so far tried a number of modifications to the board to see if we could isolate the source of the 20 kHz noise:

- Adding a Faraday cage over the input connectors
- Adding a Faraday cage over the preamps
- Shorting the signal input pins
- Disabling the PA/S 40 MHz clock
- Removing the AC-coupling capacitor in the input protection networks, in order to disconnect the PA/S input
- Partially disabling the preamp
 - `ON_pa=0, ON_g20=1, ON_lg_s1=1, ON_hg_S1=1, ON_lg_s2=1, ON_hg_s2=1`
 - `ON_pa=0, ON_g20=0, ON_lg_s1=1, ON_hg_s1=1, ON_lg_s2=1, ON_hg_s2=1`
 - `ON_pa=0, ON_g20=0, ON_lg_s1=0, ON_hg_s1=0, ON_lg_s2=1, ON_hg_s2=1`

The 20kHz noise remained roughly consistent through all these tests

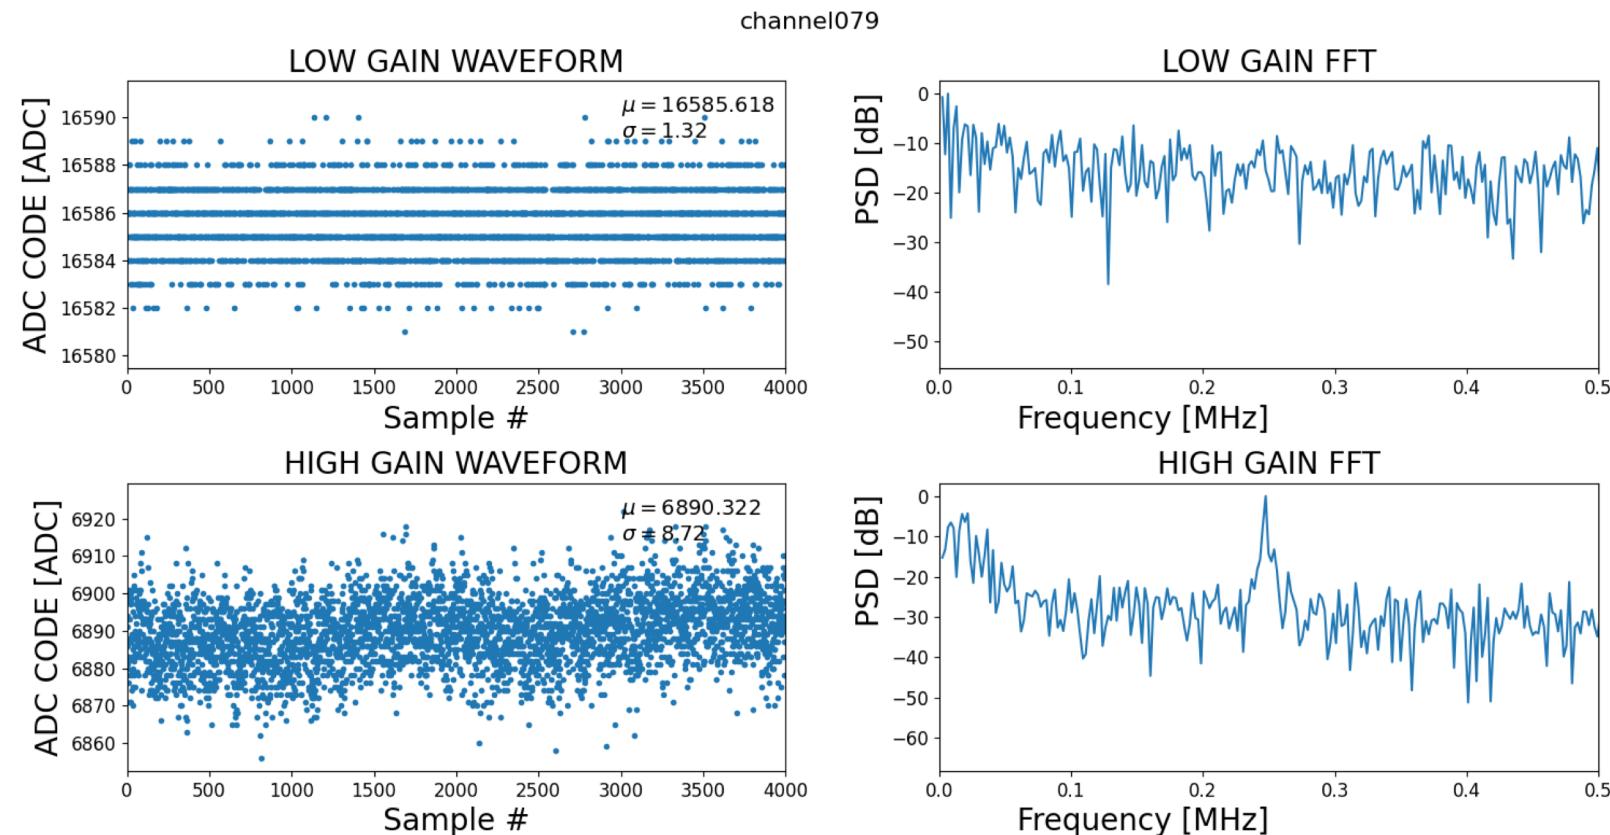
Ch79 LG - Disconnected from PA/S

- Ch79 LG can be disconnected from the PA/S
 - This was done we so we can send an external pulse to the chip
- We see the 20 kHz noise is gone in this measurement, and the noise is greatly reduced (1.3 counts, down from 4.9 counts)
- This, coupled with our other tests, implies 20 kHz noise is coming through the PA/S

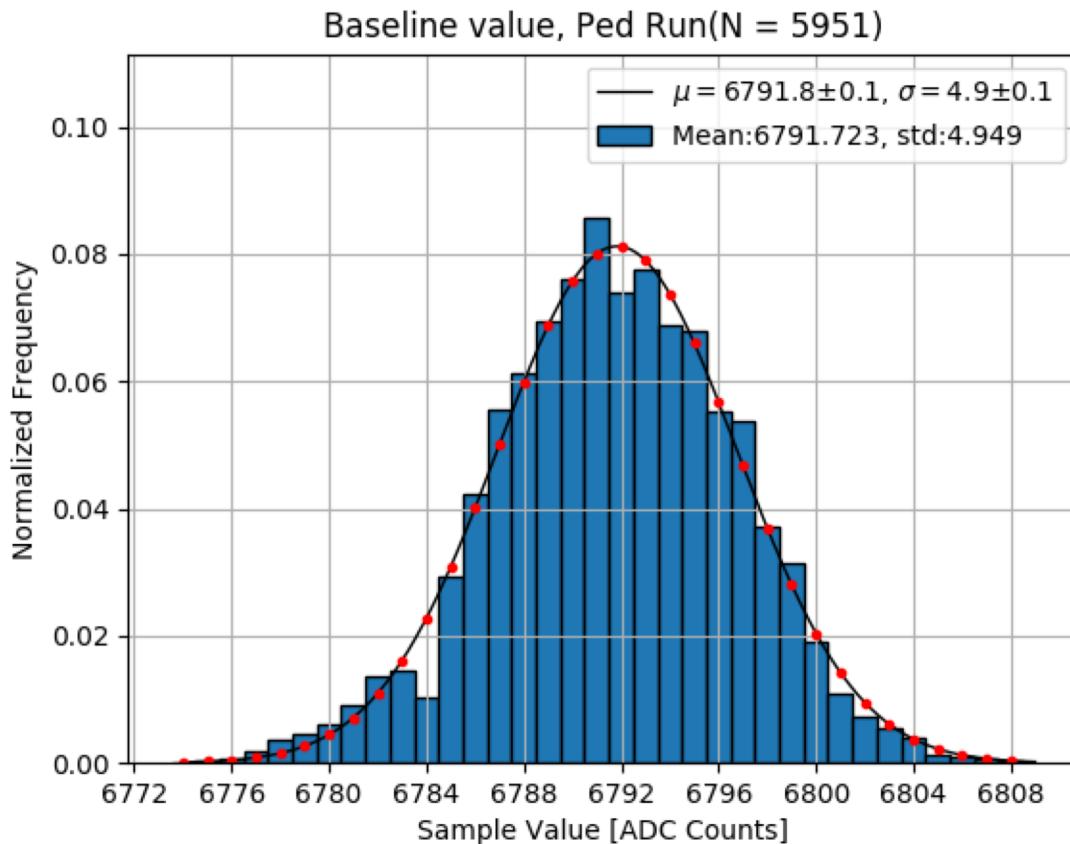
Connected to PA/S

Ch79 LG Noise Histograms

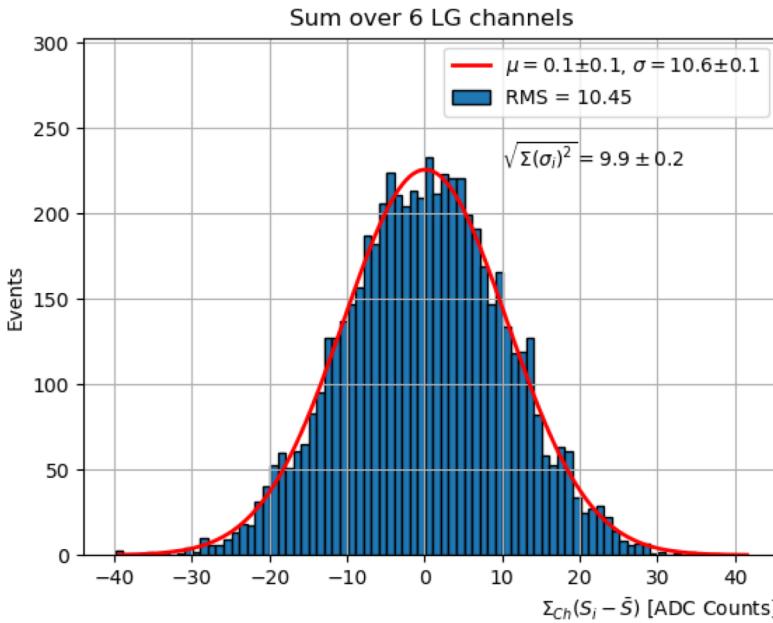
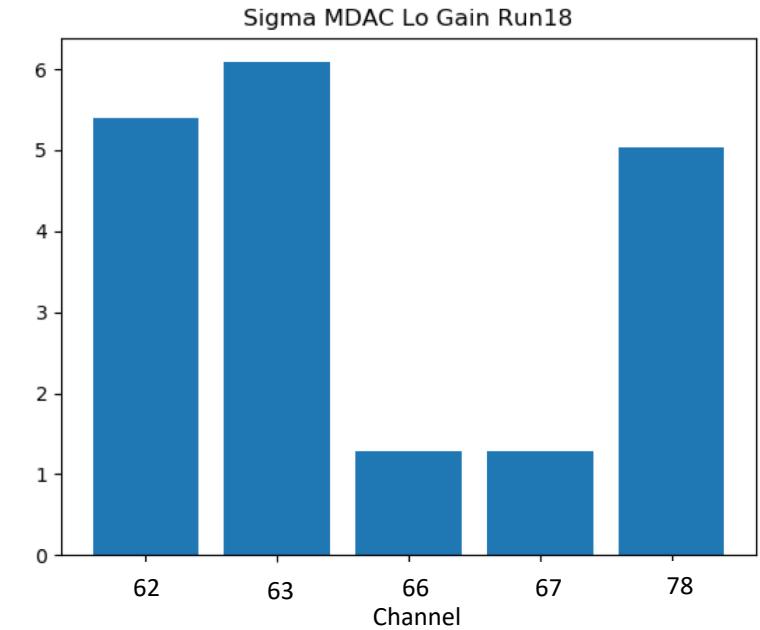
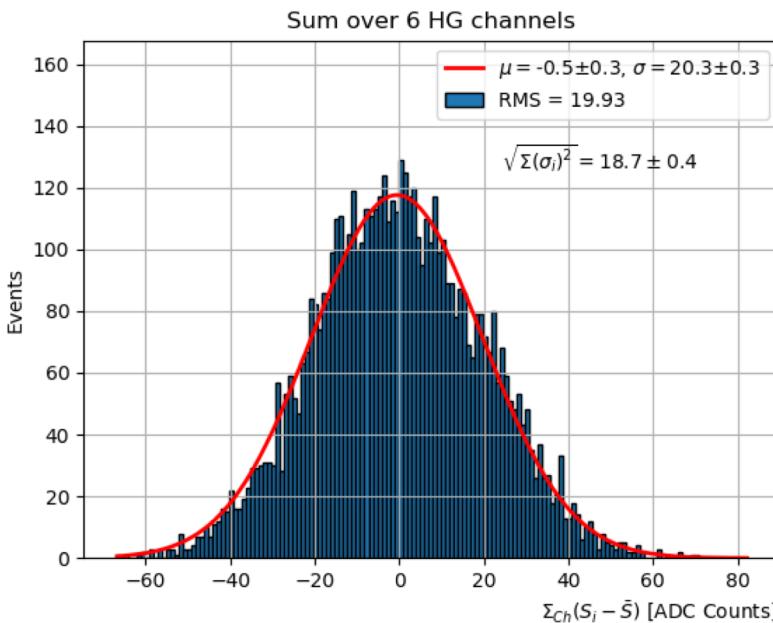
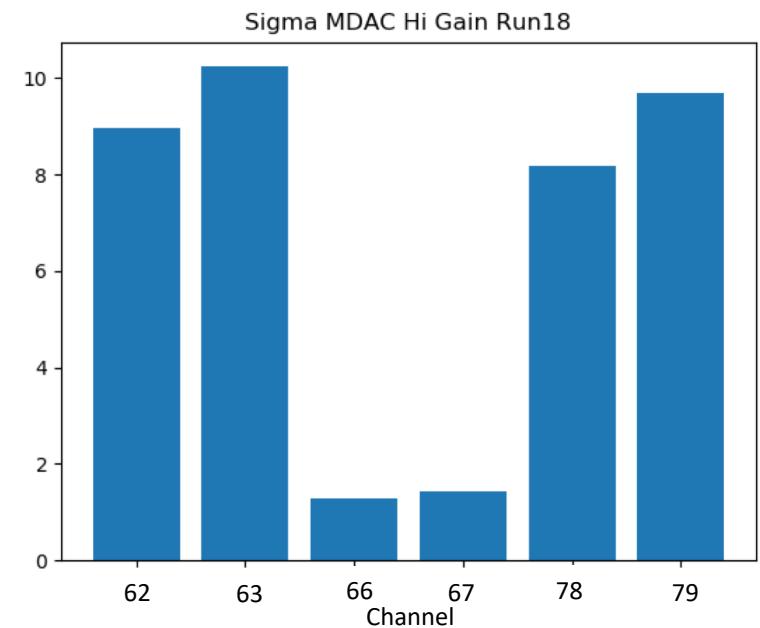
Noise Results from v1.0

Channels 66 & 67 are not connected to a LAUROC (no LAUROC17 on board)
